Appendix 3.4 - LVIA ANNEXES

EIA Review - Landscape and Trees

(Rev.5)

Annex A1: Missing Trees

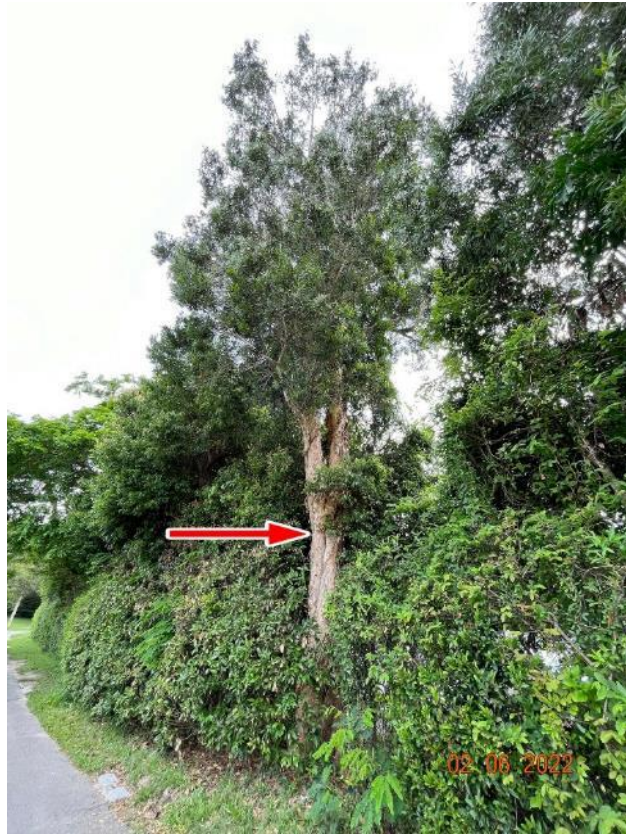
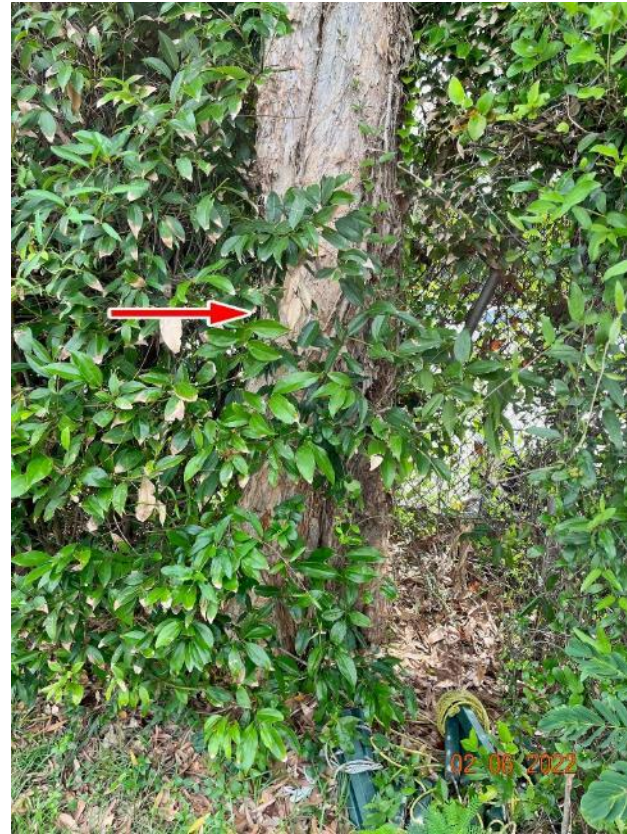
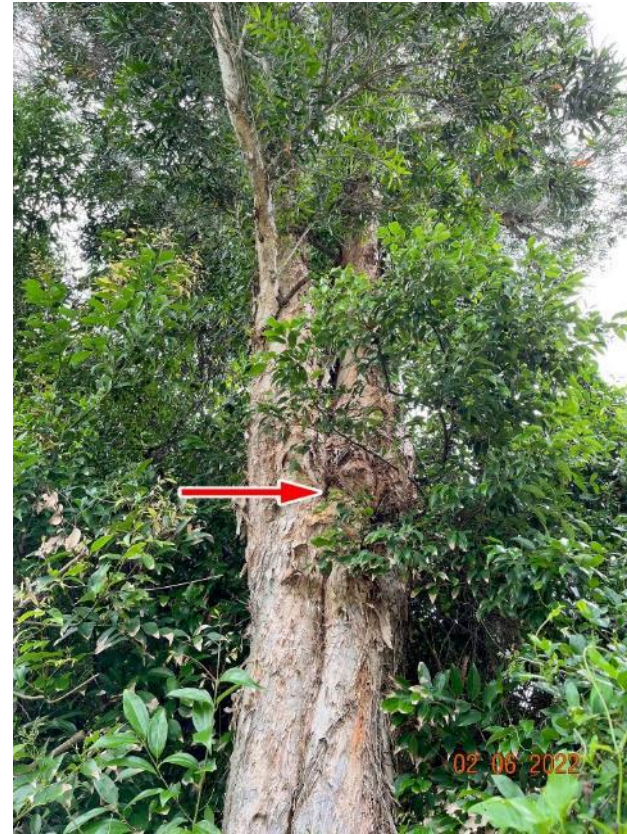
T51A (*Melaleuca cajuputi* subsp. *cumingiana*)

- Furthermore, 24 other smaller trees in the general vicinity of the Heritage Tree are also entirely missing from the Tree Survey⁹.
- There is inconsistency in the LIA in the reporting of the number of Trees of Particular Interest (TPIs) found in the PDA:

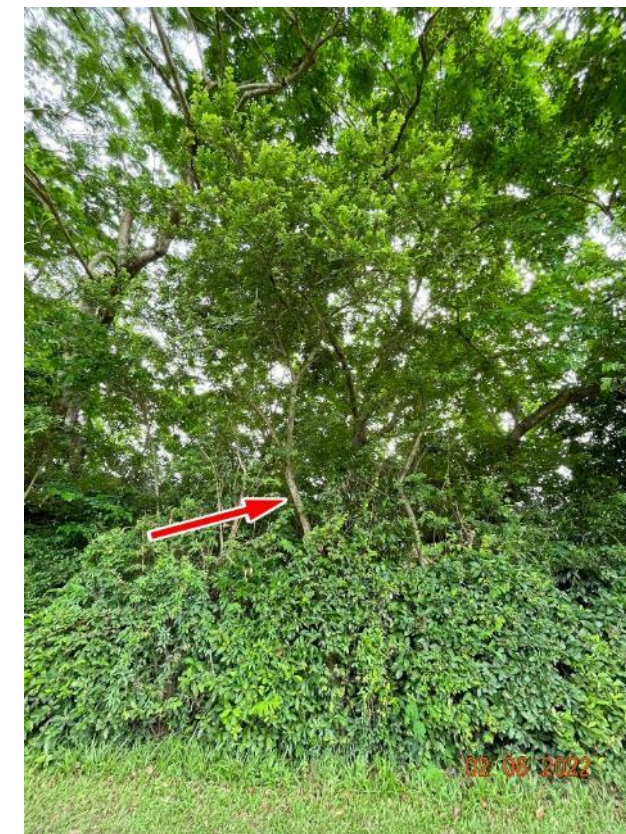
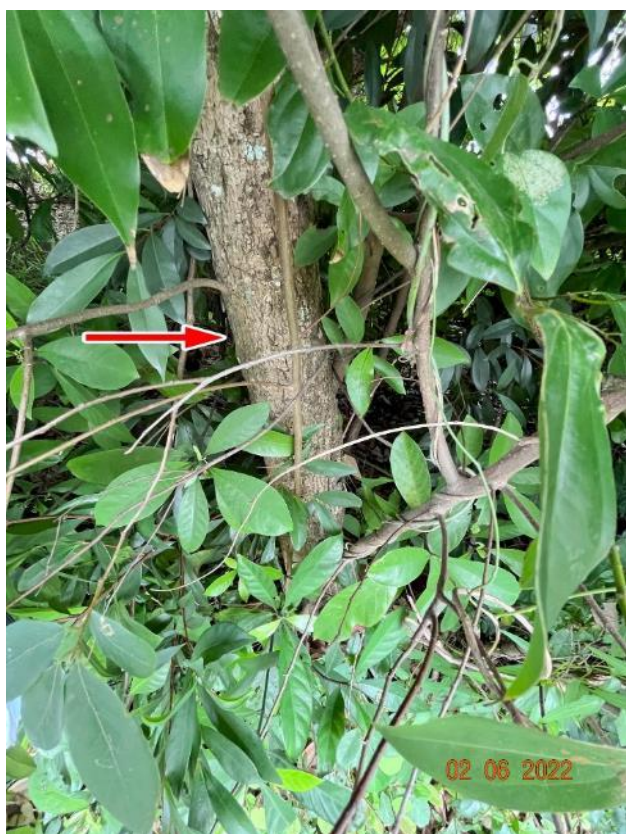
T51E (*Bridelia tomentosa*)

Tree No.	Species		URBIS Sample Audit Measurements			Form	Health condition	Structural condition	Amenity Value	Suitability for transplanting		Conservation Status (Yes/ No)	DBH>=1000m m (Yes/ No)	Maintenance department to provide comments to this Tree Survey Report		Recommendation (Retain/ Transplant/ ReMove)	Sub-area	Remarks
	Scientific name	Chinese Name	Height (m)	DBH (mm)	Crown Spread (m)					(Good/Average/Poor)	(High/ Medium/ Low)			(High/ Medium / Low)	Remarks			
T51A	<i>Melaleuca cajuputi subsp. cumingiana</i>	白千層	10	490	6	A	A	A	M	L	-	No	No					Codominant stems with narrow union.
T51B	<i>Cinnamomum burmannii</i>	陰香	7	150	5	A	A	A	L	L	-	No	No					Pruned branches.
T51C	<i>Cinnamomum burmannii</i>	陰香	8	200	6	A	A	A	L	L	-	No	No					Pruned branches.
T51D	<i>Cinnamomum burmannii</i>	陰香	6	95	5	A	A	A	L	L	-	No	No					-
T51E	<i>Bridelia tomentosa</i>	土蜜樹	6	95	4	A	A	A	L	L	-	No	No					Slightly crooked trunk.

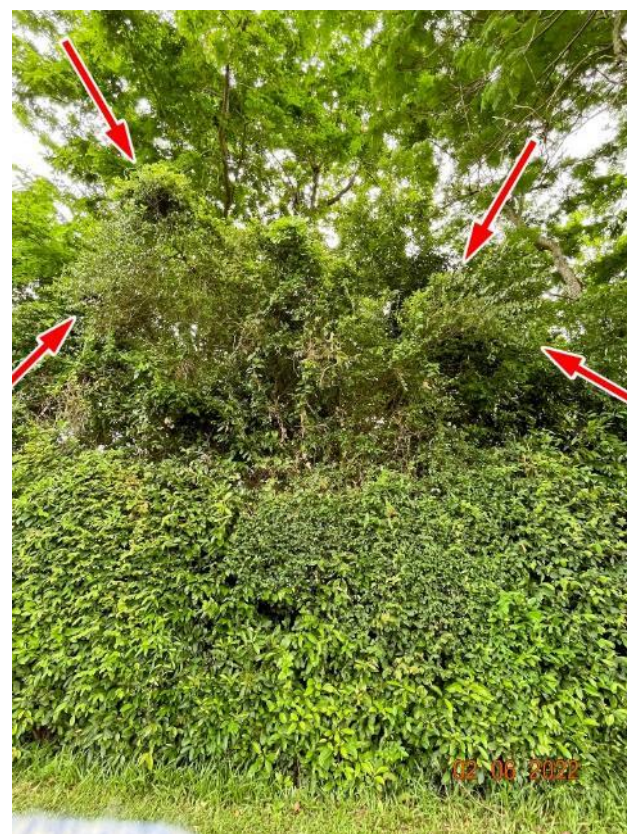
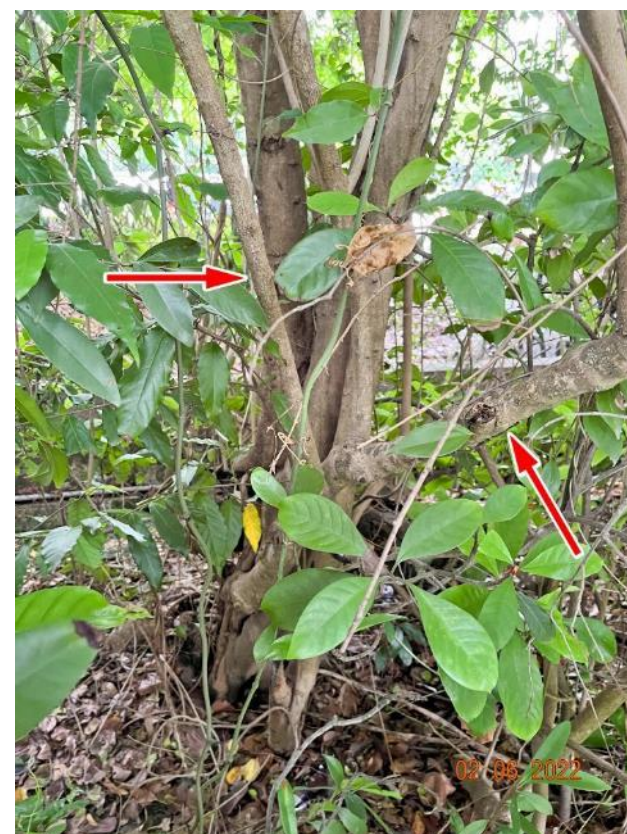
T51F (*Ligustrum sinense*)

T51F	<i>Ligustrum sinense</i>	山指甲	6	95	5	A	A	A	L	L	-	No	No					Multi-trunk.
T51G	<i>Bridelia tomentosa</i>	土蜜樹	6	95	4	A	A	A	L	L	-	No	No					Multi-trunk, seam observed on trunk of a major trunk.
T51H	<i>Bridelia tomentosa</i>	土蜜樹	6	95	3	A	A	A	L	L	-	No	No					Torned wound on the top of branch, seam observed on a main branch.
T51I	<i>Ligustrum sinense</i>	山指甲	5	95	5	P	A	A	L	L	-	No	No					Multi-trunk, leaning.
T51J	<i>Syzygium hancei</i>	韓氏蒲桃	7	150	5	A	A	A	L	L	-	No	No					-
T51K	<i>Cinnamomum burmannii</i>	陰香	6	100	4	A	A	A	L	L	-	No	No					-
T51L	<i>Cinnamomum burmannii</i>	陰香	7	150	5	P	A	A	L	L	-	No	No					Leaning.
T51M	<i>Cinnamomum burmannii</i>	陰香	8	180	5	A	A	A	L	L	-	No	No					-
T51N	<i>Cinnamomum burmannii</i>	陰香	8	100	5	P	A	A	L	L	-	No	No					Slightly leaning.
T51O	<i>Syzygium hancei</i>	韓氏蒲桃	8	110	5	A	A	A	L	L	-	No	No					-
T51P	<i>Cinnamomum burmannii</i>	陰香	4	100	3	P	A	A	L	L	-	No	No					Poorly executed pruning branch.

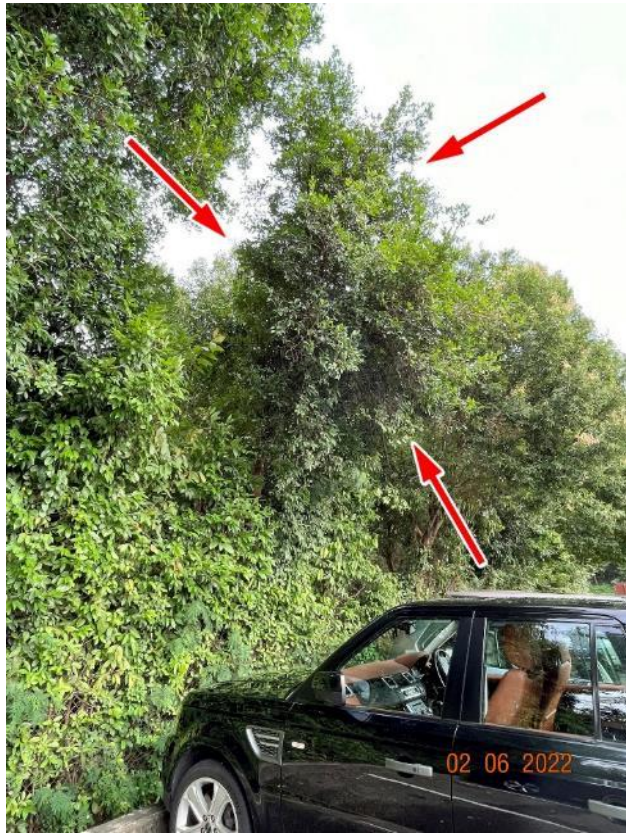
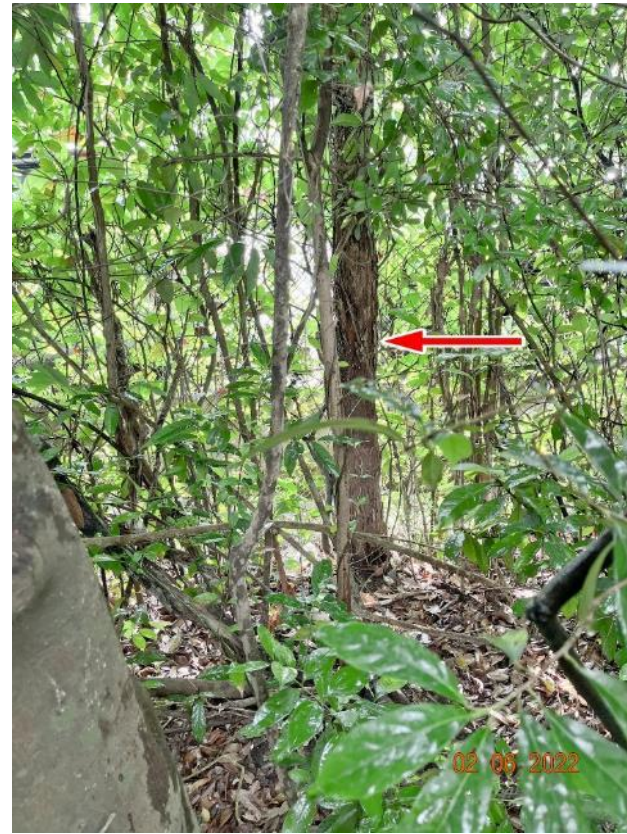
T51Q (*Syzygium hancei*)

T51Q	<i>Syzygium hancei</i>	韓氏蒲桃	6	100	4	A	A	A	L	L	-	No	No					-
T51R	<i>Cinnamomum burmannii</i>	陰香	7	160	6	A	A	A	L	L	-	No	No					Codominant stems.
T51S	<i>Cinnamomum burmannii</i>	陰香	7	160	6	A	A	A	L	L	-	No	No					Slightly leaning.
T51T	<i>Sterculia lanceolata</i>	假蘋婆	6	110	5	P	A	A	L	L	-	No	No					Leaning tree with asymmetrical tree crown.
T51U	<i>Cinnamomum burmannii</i>	陰香	8	170	5	A	A	A	L	L	-	No	No					Branches formed from epicormics.
T51V	<i>Cinnamomum burmannii</i>	陰香	7	95	4	A	A	A	L	L	-	No	No					Branches formed from epicormics.
T51W	<i>Ligustrum sinense</i>	山指甲	4	110	4	P	A	A	L	L	-	No	No					Leaning, epicormics at trunk base, dead stub.
T51X	<i>Celtis sinensis</i>	朴樹	8	290	6	A	A	A	L	L	-	No	No					Slightly leaning.
T51Y	<i>Delonix regia</i>	鳳凰木	12	917	10	A	A	A	M	L	-	No	No					Growing next to u-channel, codominant stems, torn wounds on branches.

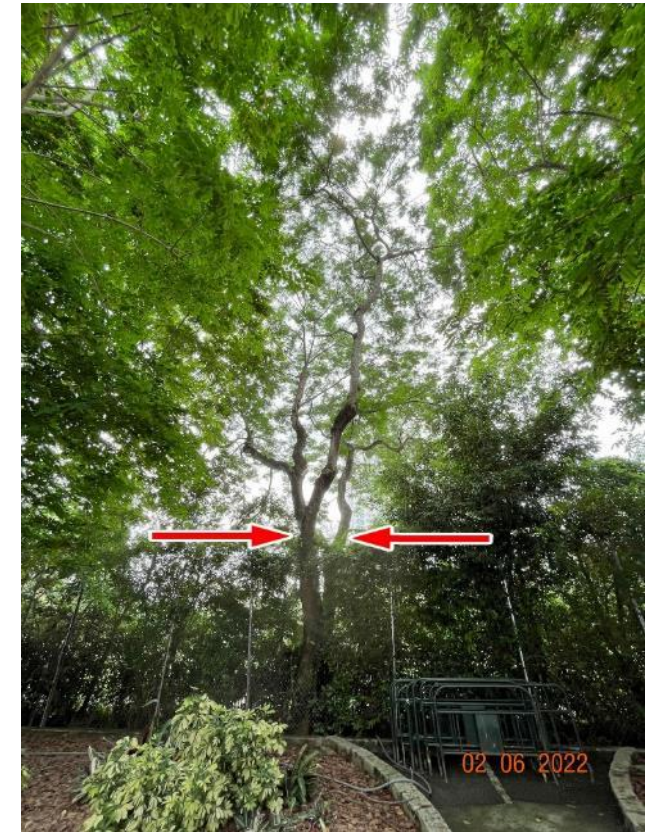
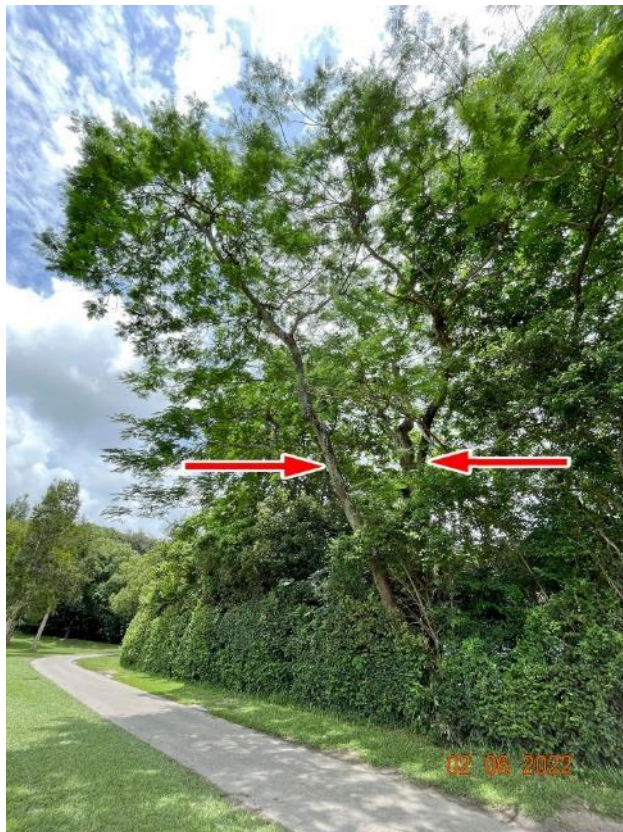
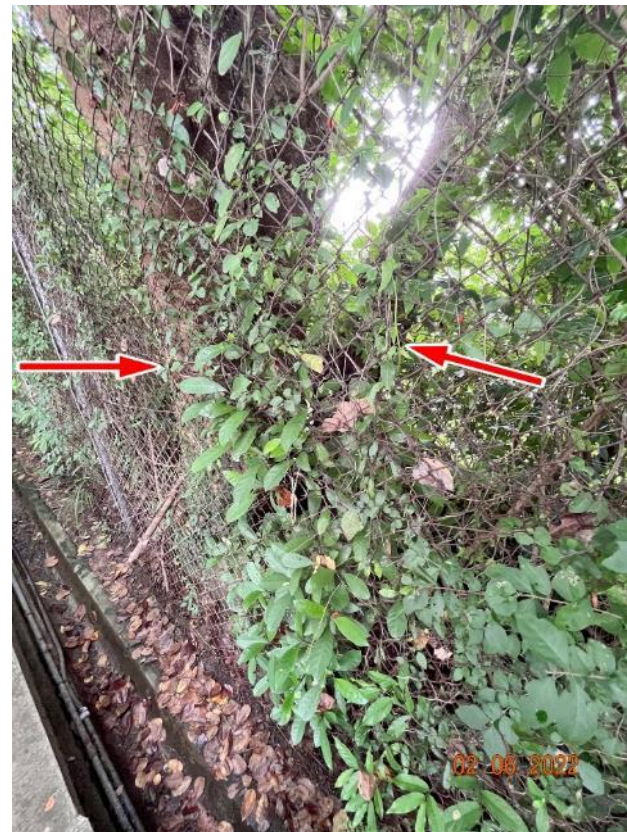
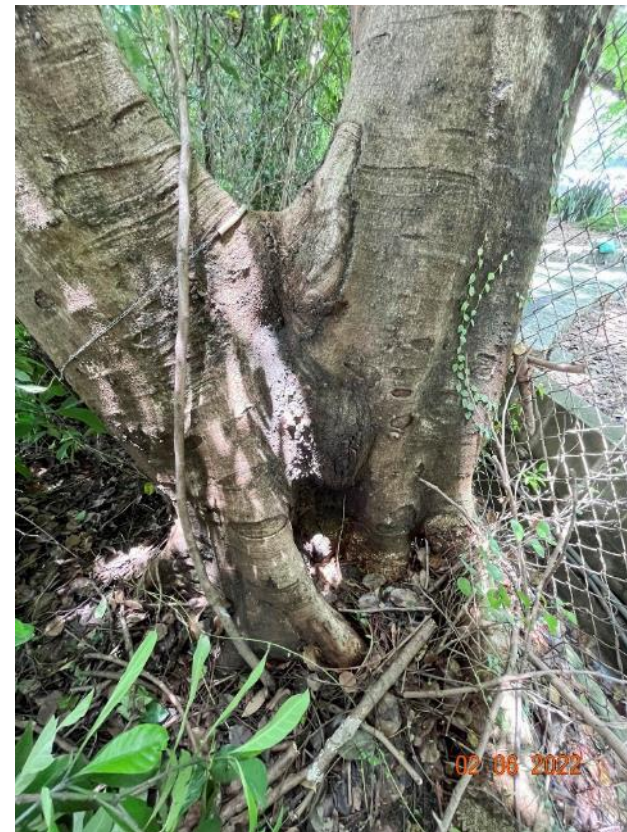
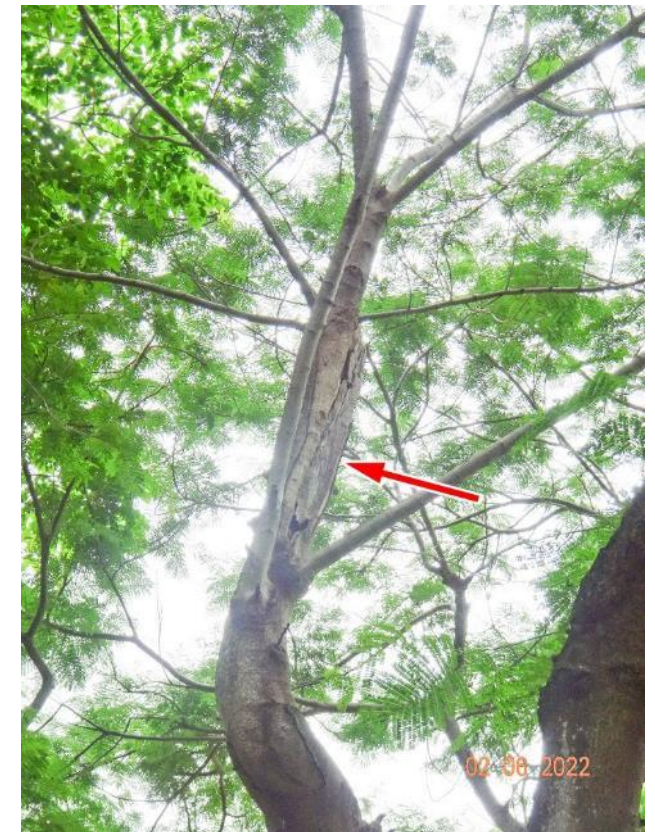
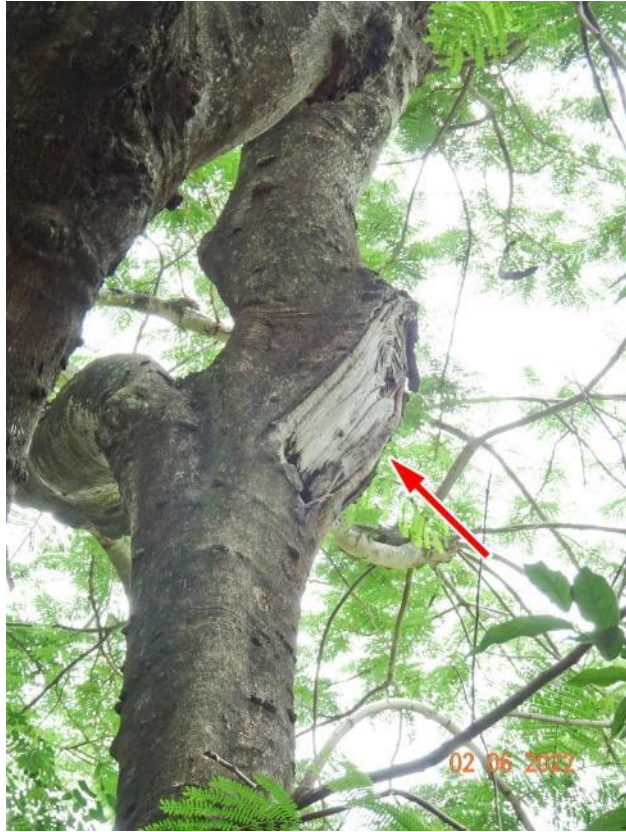
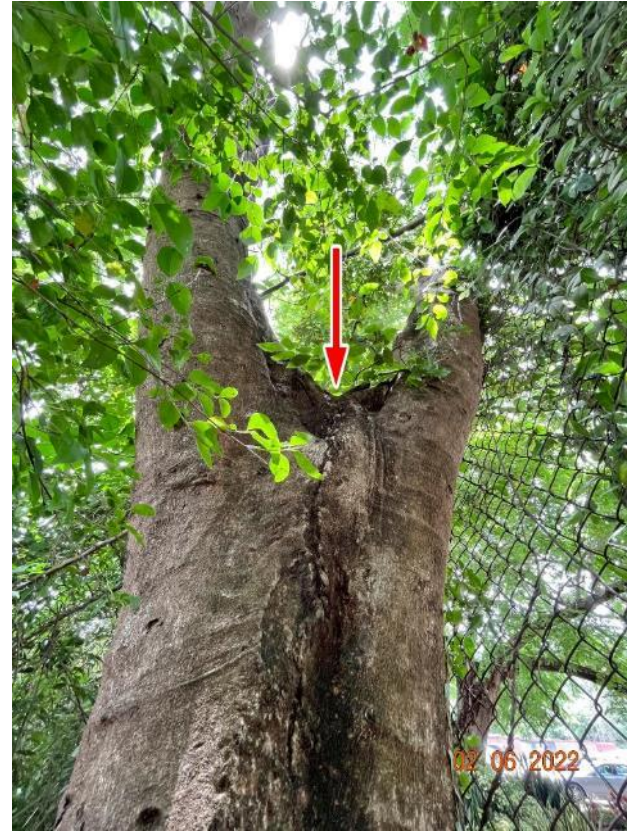
T51Y (*Delonix regia*)

- One very obvious and very large existing tree (*Delonix regia* – girth 917mm) located near trees T36 and T37 is totally missing from the survey plans⁷. This

tree was identified as a **Heritage Tree** in the 2020 study⁸ undertaken by Prof. C Y Jim *et al.* It is very surprising that such a huge and important tree should be entirely missing from a thorough and competently performed Tree Survey.
